# Inspeksjonsrapport

## Inspection Report

<b>Oppdragsgiver</b> <i>Client</i> Static Seals AS Rådmann Friis vei 45, 3610 Kongsberg		<b>Utførende enhet/lab.</b> <i>Department/laboratory responsible</i> Kiwa AS PB 1019 3601 KONGSBERG	
<b>Rapportnr.</b> <i>Report no.</i> <b>24NO-00410OR01</b>			
<b>Tittel</b> <i>Title</i> <b>Third party verification of test according to EN-545 on ductile cast iron pipe with dimension DN300. At Ulefos Esco AS.</b>			
<b>Inspeksjon utført ...</b> <i>Inspection performed...</i> - i felt <i>In field</i> JA - i fabrikk i produksjon <i>in fabric in production</i> Nei No	<b>Inspeksjon utført av</b> <i>Inspection performed by</i> Asgeir Haukaas

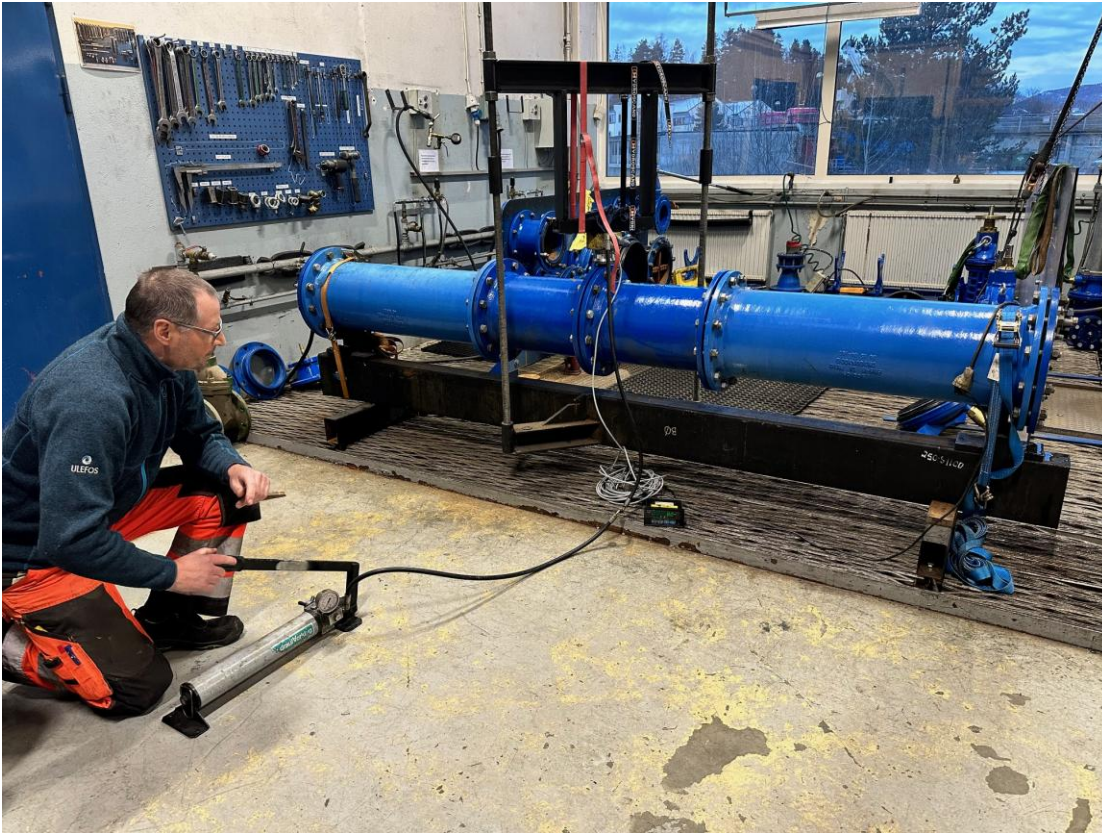
The test was set up without overhang as indicated in picture 1. The bending moment shall be according to table 12 in EN 545:2010.

Photo 1. Test setup. 3-point bending test is performed.

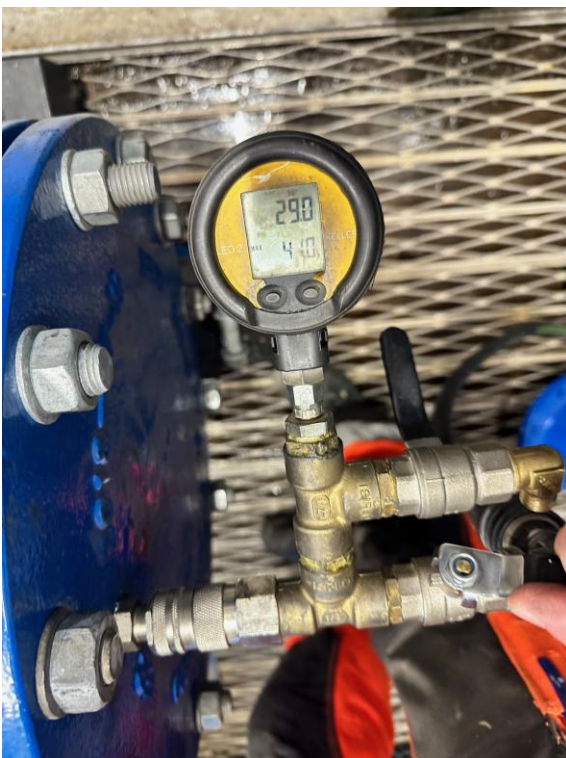
The pipe was filled with water, then vented and pressurized with 29 BARg. The pressure was held for 2 hours under a constant force of 35.4kN. The bending moment shall be according to table 12 in EN 545:2010.

Photo 2. The pipe was pressurized with water up to 29 barg

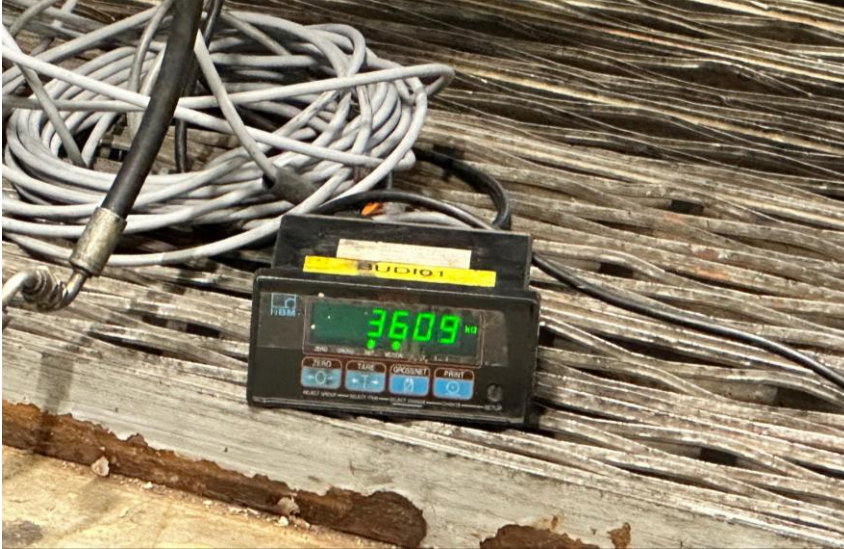
Photo 3. Three-point bending force was measured 3609KG (35.4kN)

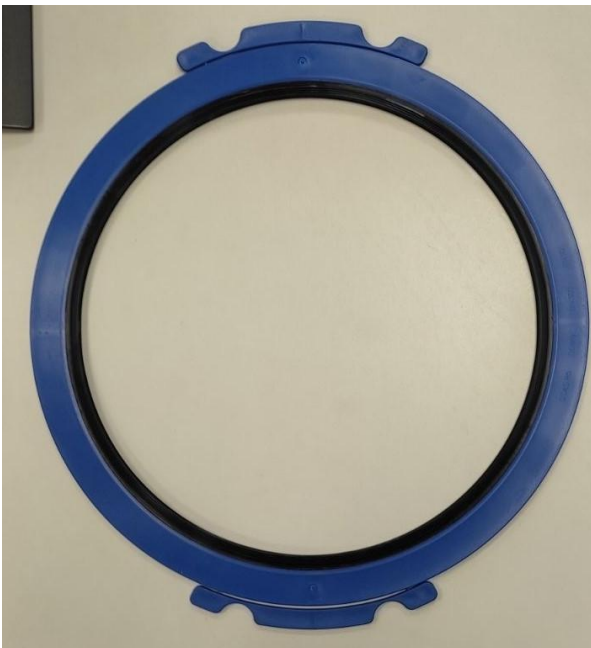
Photo 4. Gasket Dn300

Pressure test of gasket shows no leakage after 2 hours of constant three-point load. The test meets the requirements of EN 545:2010
