# Inspeksjonsrapport

## Inspection Report

<b>Oppdragsgiver</b> <i>Client</i> Static Seals AS Rådmann Friis vei 45, 3610 Kongsberg		<b>Utførende enhet/lab.</b> <i>Department/laboratory responsible</i> Kiwa AS PB 1019 3601 KONGSBERG	
<b>Rapportnr.</b> <i>Report no.</i> <b>24NO-00410OR01</b>			
<b>Tittel</b> <i>Title</i> <b>Third party verification of test according to EN-545 on ductile cast iron pipe with dimension DN300. At Ulefos Esco AS.</b>			
<b>Inspeksjon utført ...</b> <i>Inspection performed...</i> - i felt <i>In field</i> JA - i fabrikk i produksjon <i>in fabric in production</i> Nei No	<b>Inspeksjon utført av</b> <i>Inspection performed by</i> Asgeir Haukaas

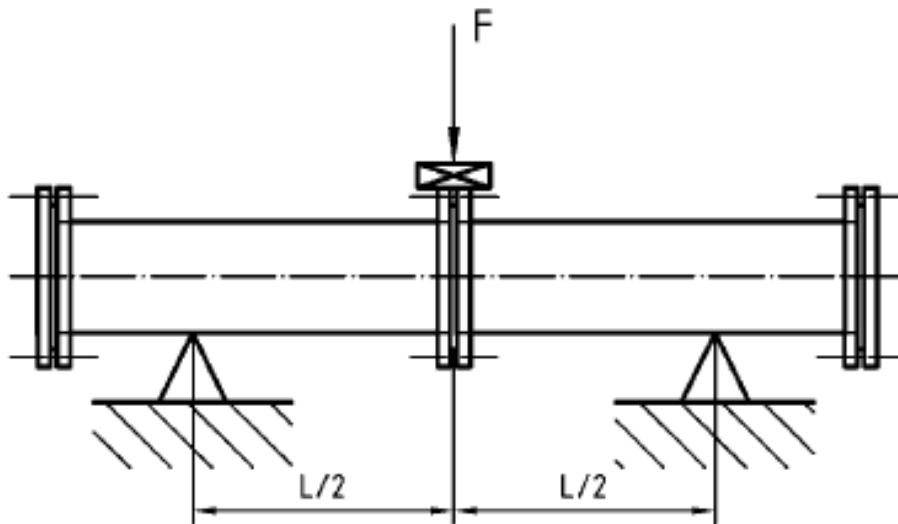
**Figure 3 — Strength and leak tightness test for flanged joints**

The test was set up without overhang as indicated in picture 1. The bending moment shall be according to table 12 in EN 545:2010.

The length of the pipes was 2 pcs. of 500mm and 2 pcs. of 1000mm. The gaskets build approx. 5mm each. Total 5 gaskets = 25mm. Total 3025mm.
